TEST REPORT
SAF 2103-1/02

E.U.T. : Pneumatic Actuator
Model : AT300 D A F07-F10/22

Client : **Air Torque S.p.a.**
Via Palazzo, sn
24061 Albano S.A. (BG) - Italy

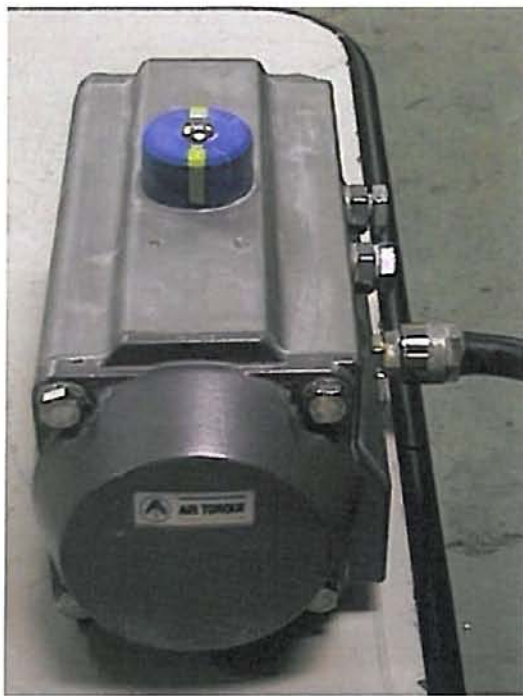
Fig.1 E.U.T. inside water tank

IPX7:

Level immersion depth : 1m (below the water surface)
Water temperature : 20°C
Test Duration : 30min

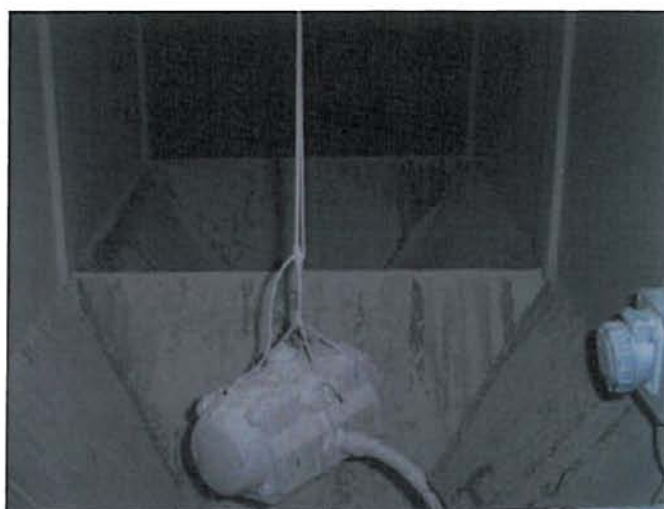
Fig.2 E.U.T. inside Dust chamber

IP6X

Enclosure category.....: 1
Internal volume.....: 4.138,83 cm³
Extraction rate at 20mbar.....: < 40 volumes per hour
Test Duration.....: 8h

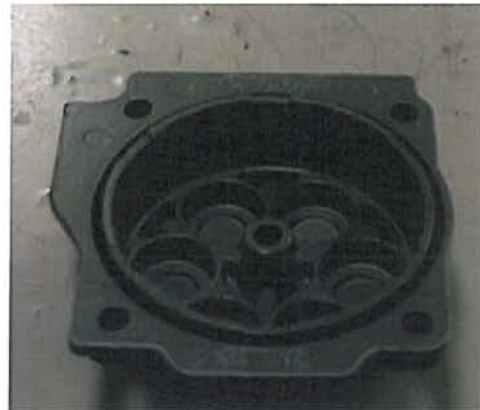
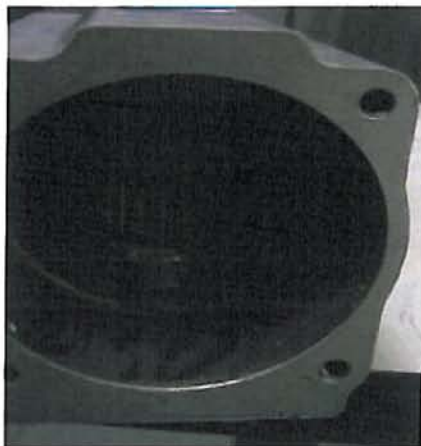
After Test

The EUT is **COMPLIED** with **IP67** as:

- * The test probe 1mm not entry inside the enclosure;
- * water was not present inside the enclosure;
- * dust was not present inside the enclosure.
